Preliminary Report on Post-Earthquake On-Site Investigation after the 2013 Aceh, Indonesia Earthquake

Yulia Hayati, Toyohashi University of Technology
 Jafril Tanjung, Andalas University
 Yasushi Sanada, Osaka University

4/August/2013

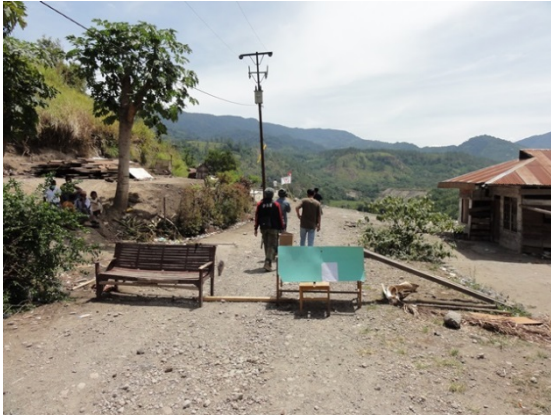
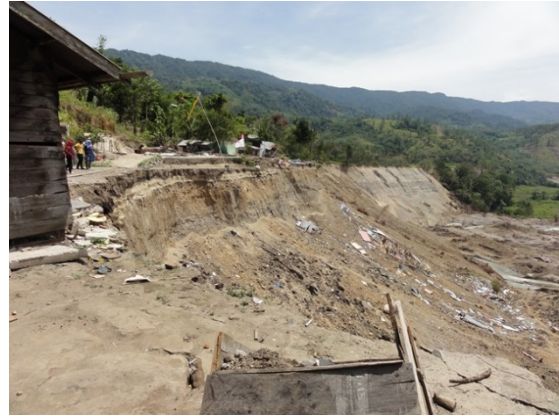
(a) Serempah on the epicenter

| 26/July/2013 | Notes |
|---|--|
| 13:30 – 13:45 Investigation at Serempah | Dead end due to large landslide (Photo 1) |

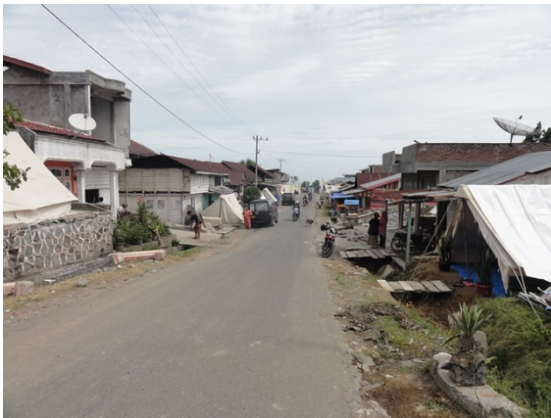
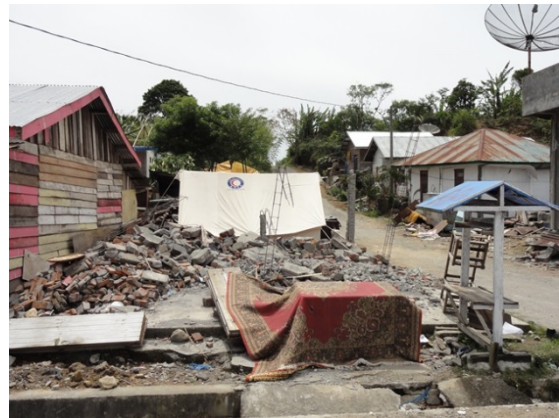
(b) Ratawali at about 10 km from the epicenter

| 26/July/2013 | Notes |
|---|--|
| 10:20 – 12:30 Investigation at Ratawali | Heavy damage to confined masonry (Photo 1) |

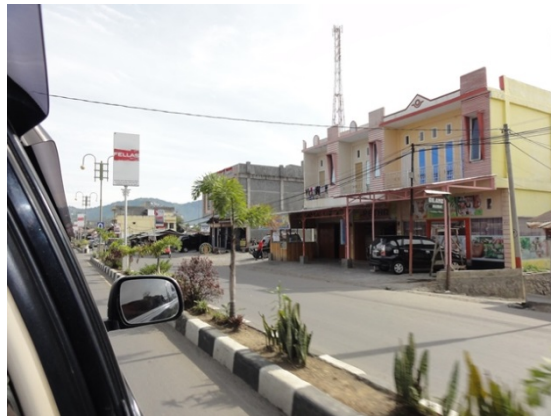
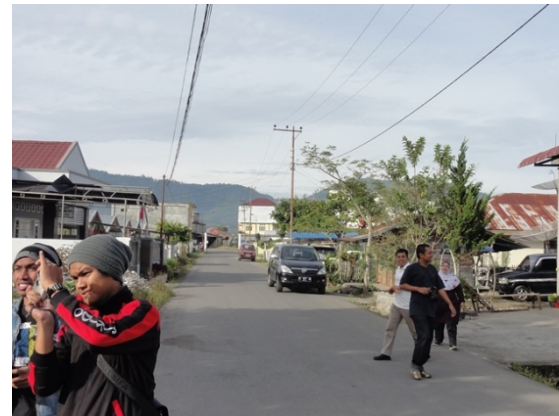
(c) Takengon

| 26/July/2013 | Notes |
|---|--|
| 8:00 – 9:20 Investigation in Takengon | Relatively light damage (Photo 1) |

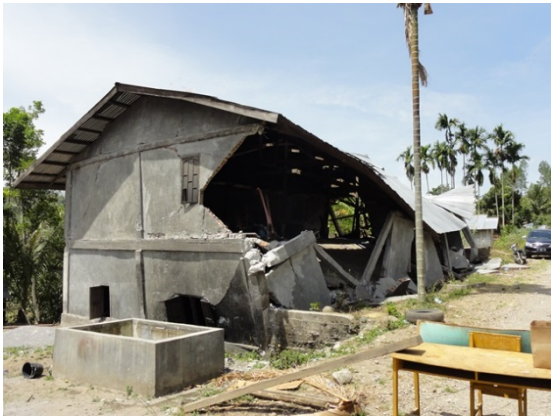
(a) Complete collapse

Photo 3 Typical damage to confined masonry

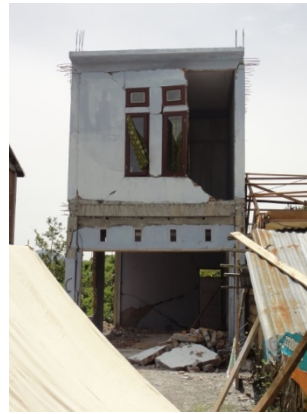
(b) Out-of-plane failure of wall

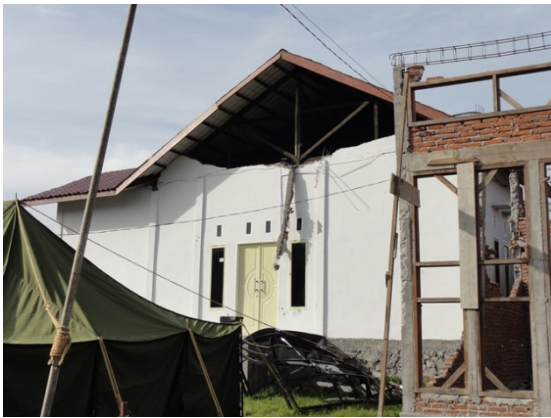
(c) Gable wall failure

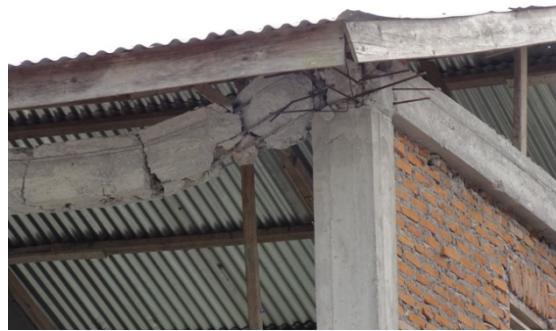
(d) Collapse of confining element

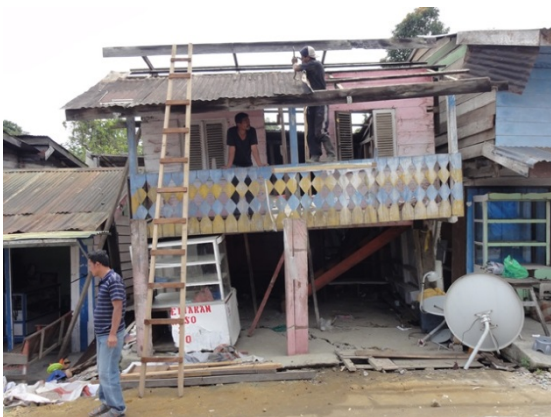
(a) Damage due to ground settlement

Photo 4 Damage to timber

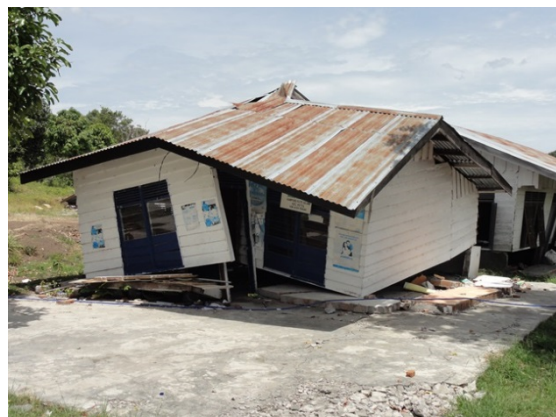
(b) Damage due to spandrel wall collapse

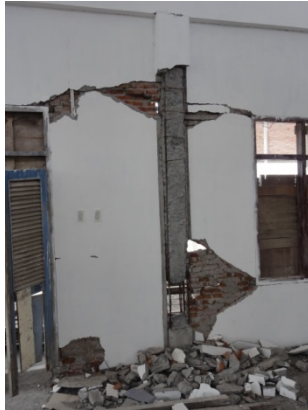
Building structural systems can be roughly categorized into four types: 1) confined masonry, 2) timber, 3) timber with masonry spandrel walls, and 4) reinforced concrete, as shown in Photo 2. The first three types except for reinforced concrete were typical structures at the mountain range close to the epicenter. Confined masonry buildings suffered from the most severe damage: complete collapse, out-of-plane failure of walls, etc., as shown in Photo 3. On the other hand, damage to timber structures was generally lighter, however, some of them leaned due to ground settlement or damage to masonry spandrel walls, as shown in Photo 4. Only one sample of reinforced concrete building, which was found at the mountain range, also suffered from severe damage, as shown in Photo 5.

(a) Severely damaged column

Photo 5 Damage to reinforced concrete

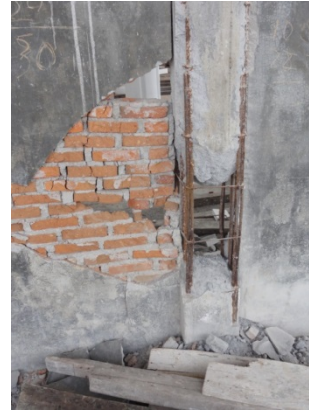
(b) Close-up of bottom
