**Organization for Development, Renovation and Equipping Schools
of I.R.Iran (DRES)**

A preliminary report on school buildings performance during M 7.3 Ezgeleh, Iran earthquake of November 12, 2017

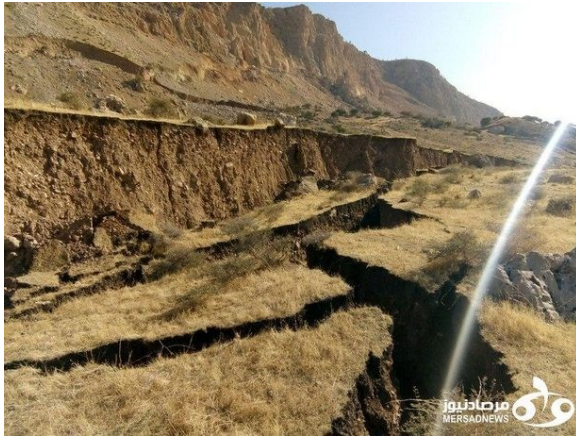
a) Surface rupture (Photo from www.Mersadnews.ir)

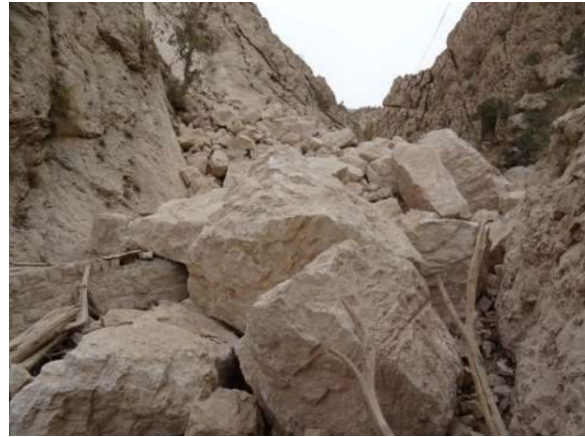
b) Rock falls (Photo from IIEES)

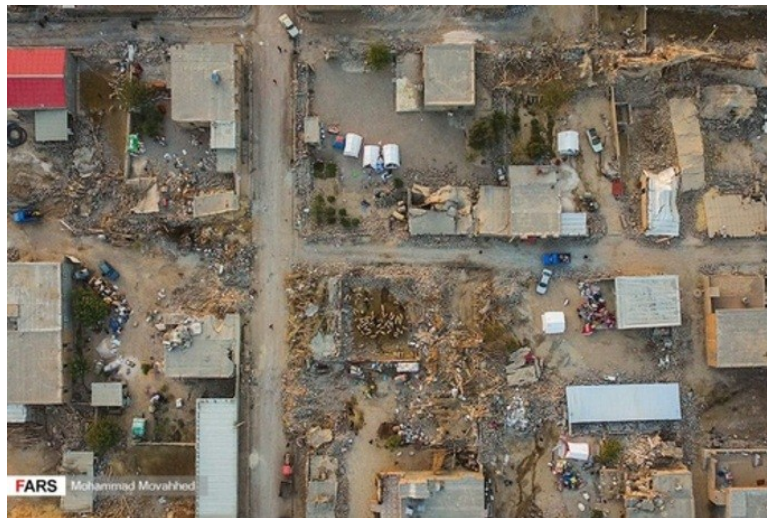
Fig. 12. An example of a collapse residential building (www.tabnak.ir)

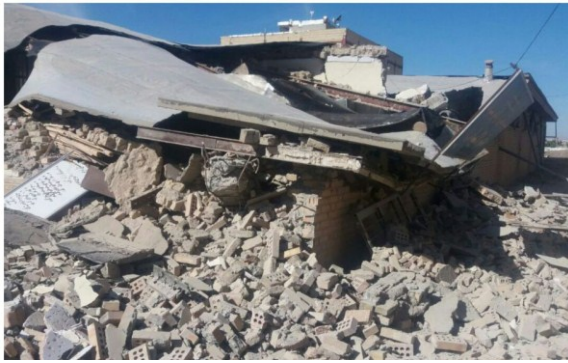
a) Collapse of school building

Fig. 13. Total and partial collapse of old URM school buildings with no confinement

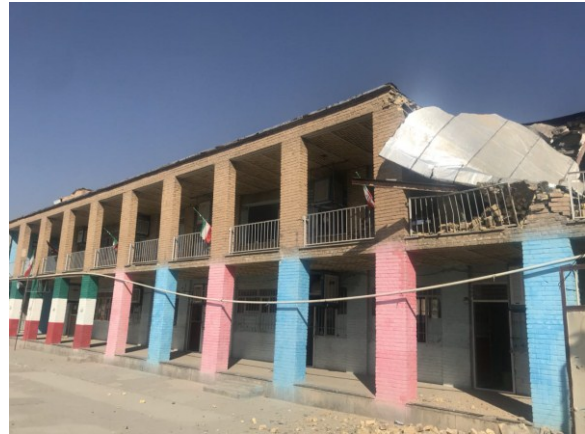
b) A partially collapsed school building

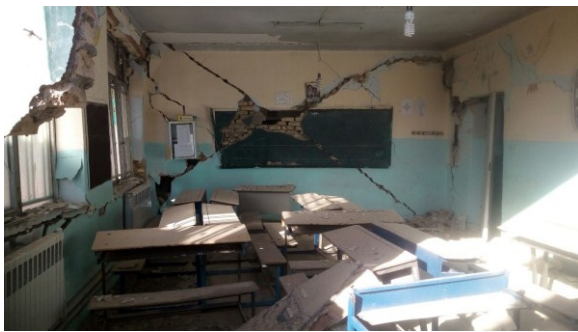
a) A classroom with severe cracks in URM walls

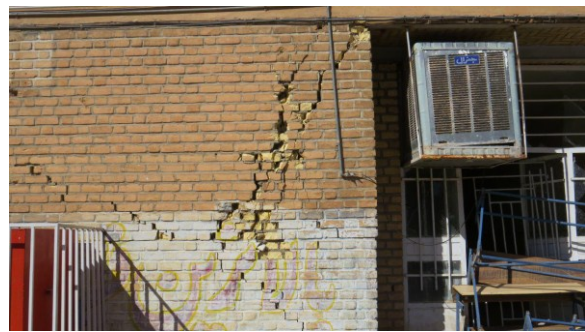
b) Major shear-sliding cracks at the URM walls

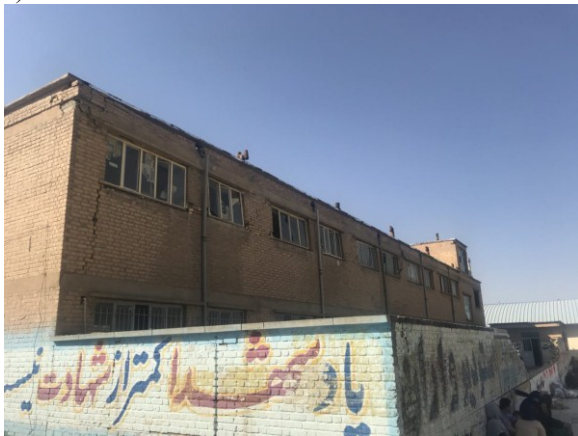
c) A two-story building with some shear cracks at the corner of the opening

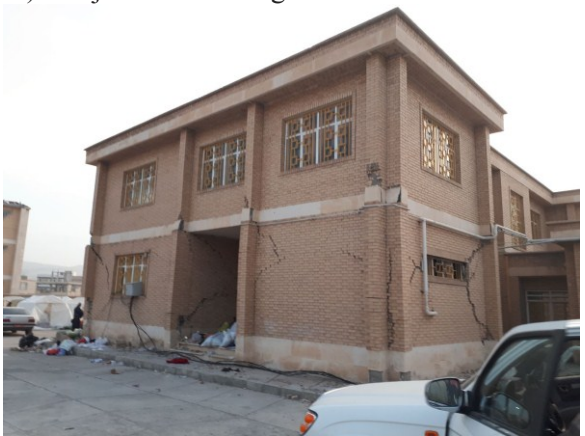
d) A confined masonry with severe cracking at the base level

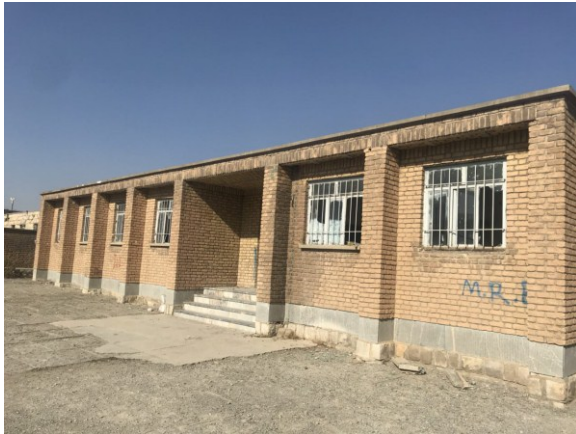
a) Slight damages in URM walls

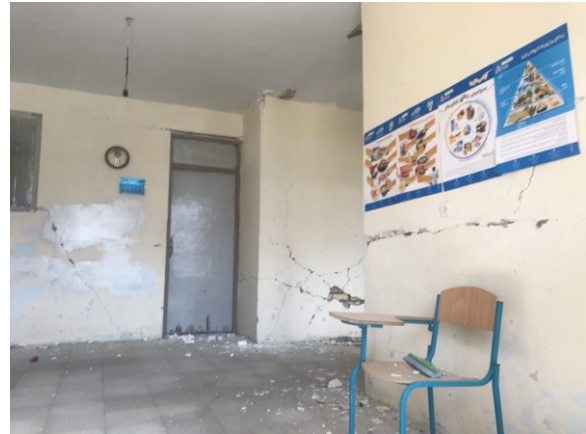
b) Moderate shear-sliding damages in URM walls

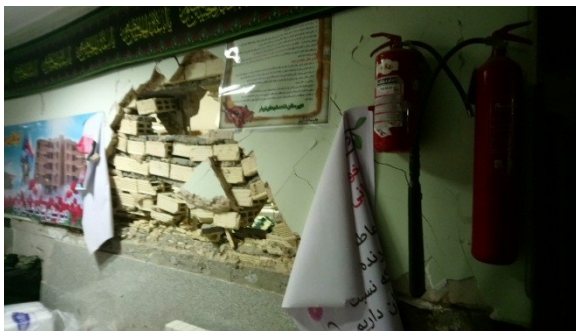
a) Major cracks and crushing of an infill wall at the base level of a three-story steel frame with shear walls

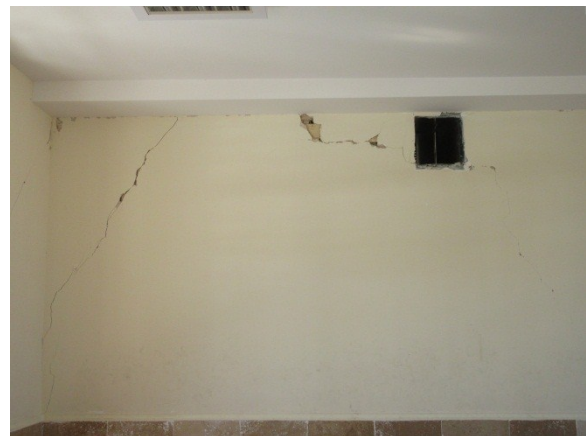
b) Cracks in the infill walls of a single-story moment-resisting frame

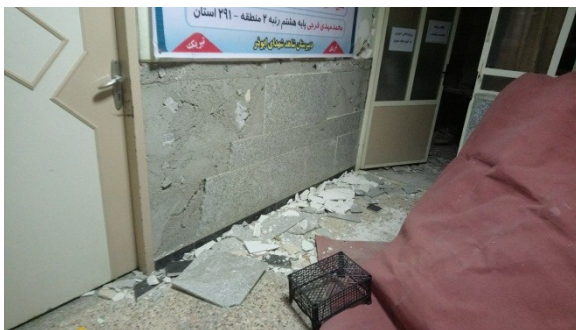
a) Falling of walls' finishing

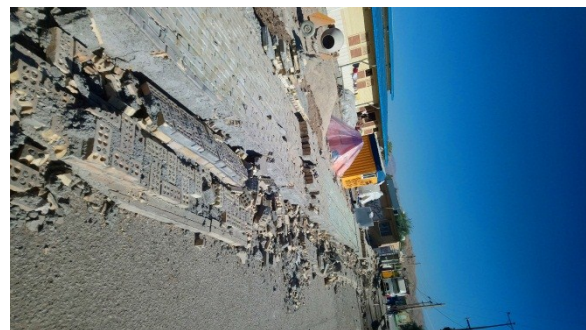
b) Collapse of fence walls

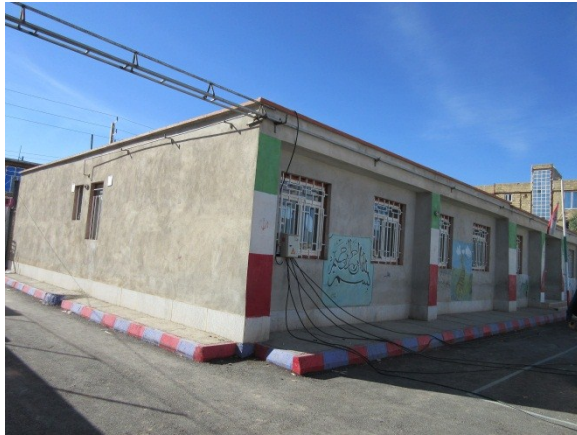
Some of the vulnerable URM school buildings were retrofitted by shotcreting of peripheral walls; these buildings showed satisfactory performance with very fine cracks at the corner of some of the walls (Fig. 18). Some details and construction phases of shotcreting of URM school buildings are shown in Fig. 19. By the way, the performance of retrofitted and recently-constructed school buildings was satisfactory compared to many other buildings in the affected area which in some cases led to their use as a temporary disaster management center. Based on the field observations, it can be concluded these buildings passed the Immediate Occupancy (IO) performance level [5-7]. Fig. 20

a) The building with few hairline cracks on some of the walls

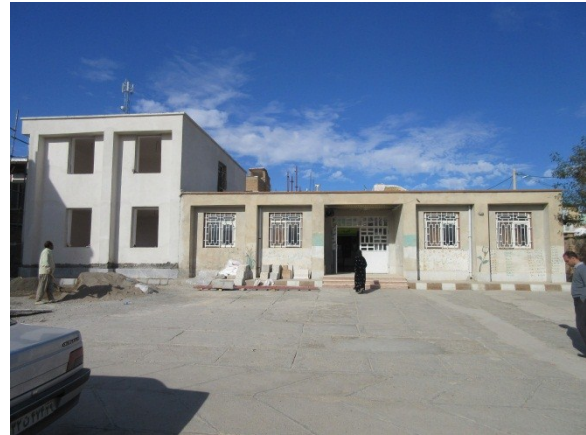
b) The retrofitted single-story unconfined URM building adjacent to the appendant newly-constructed confined URM building; both of which experienced very fine cracks

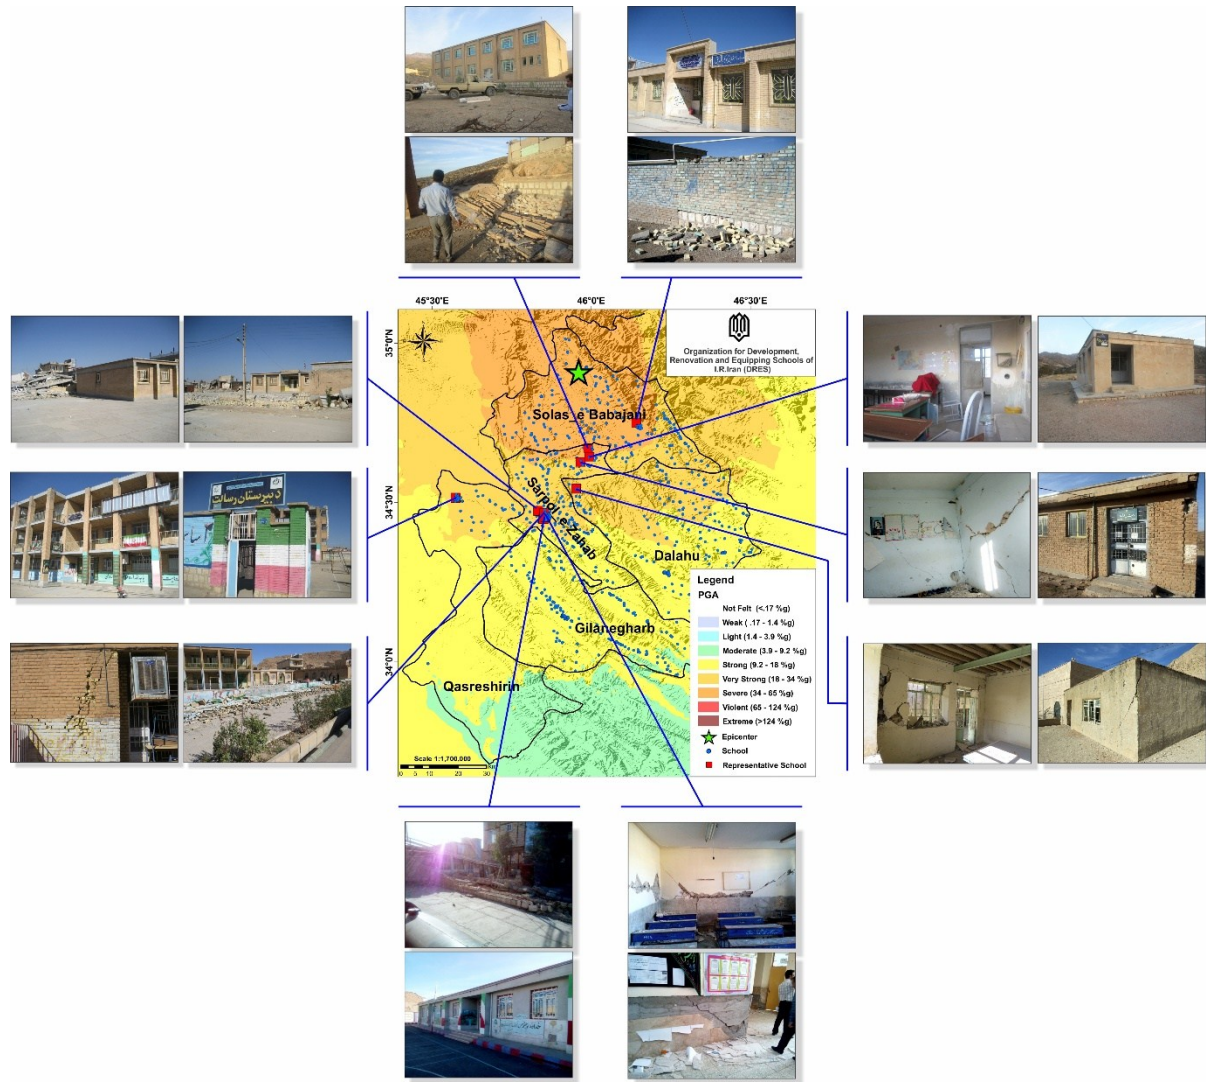
The 12th November 2017, magnitude 7.3 earthquake in Kermanshah Province can be regarded as a testimony to the importance of design and construction as per the regulations of the design codes. There were several cases in which poor design and/or construction deficiencies due to lack or insufficient supervision resulted in collapse or major damages to the newly-constructed frame buildings; whereas most of the URM buildings, widely regarded as one of the most vulnerable structural systems, which were constructed according to the codes regulations, responded satisfactorily against this major earthquake. All the retrofitted school buildings behaved satisfactorily. Few newly-constructed school buildings experienced damages in nonstructural parts and/or infill walls made of hollow clay blocks. In general, 11% of school buildings, mostly the old URM's, located in the affected areas experienced slight to severe damages. The remaining 89% of the school buildings in the affected area passed the immediate occupancy performance level. The preliminary results show that in some regions, the earthquake posed seismic demands which are considerably higher than those of the codified design-level earthquakes. As a result, severe damages in the buildings, including school buildings, located in those regions may be justified; though additional evaluations and analyses of the characteristics of the earthquake in different sites, soil conditions, structural materials and details are necessary to draw any further conclusions. The more frequently observed structural damages in some representative school buildings with their location in the stricken area are shown in Fig. 22.

Fig. 22. Structural damages in some representative school buildings
