**Executive Summary of Urgent Field Survey of Earthquake and Tsunami Disasters  
 by the 2011 off the Pacific coast of Tohoku Earthquake**

Port and Airport Research Institute (PARI) has accomplished urgent field survey of devastating multiple disasters of earthquake and tsunami by the 2011 off the Pacific coast of Tohoku Earthquake which occurred in March 11, 2011, at 14:46 local time, rating a magnitude of 9.0.

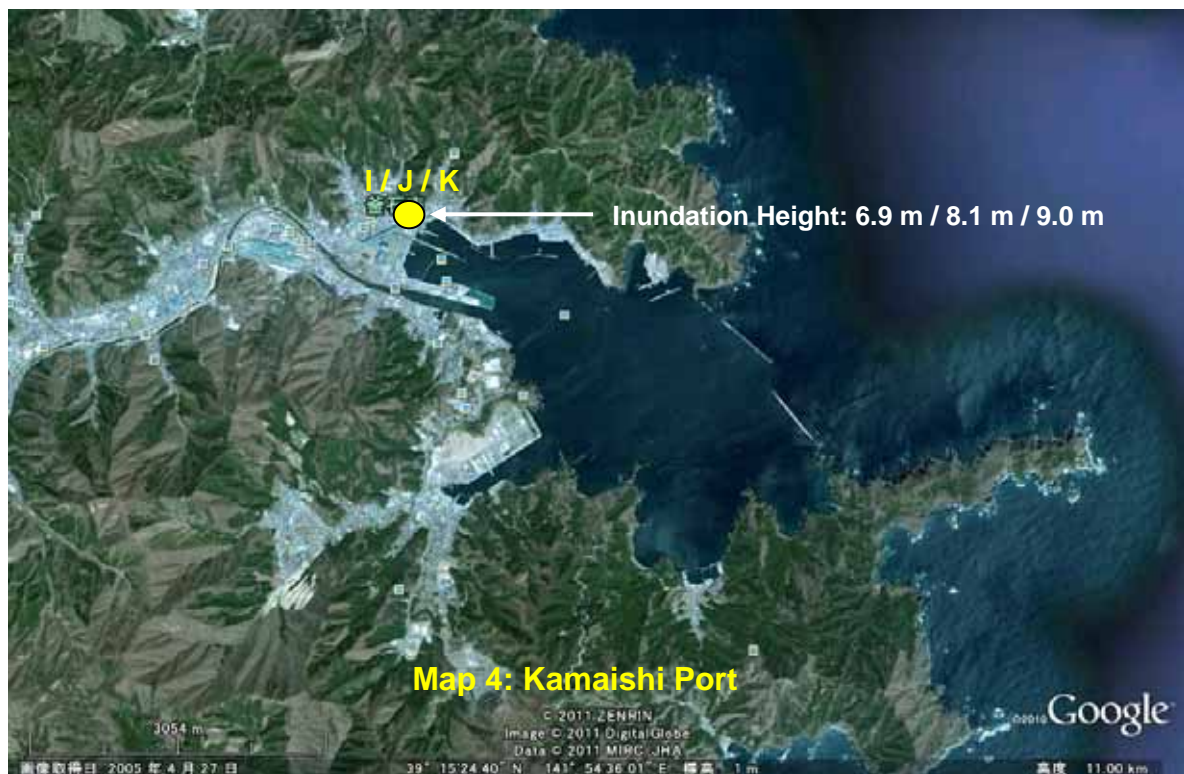
Inundation heights of 6.9 to 9.0 m were observed at the points **I**, **J**, and **K** in the inner port area. Most wooden houses were floated out completely. Reinforced concrete (RC) buildings and large-scale grain silos were damaged but not collapsed. A number of vehicles together with destroyed houses were observed floated out on the road.

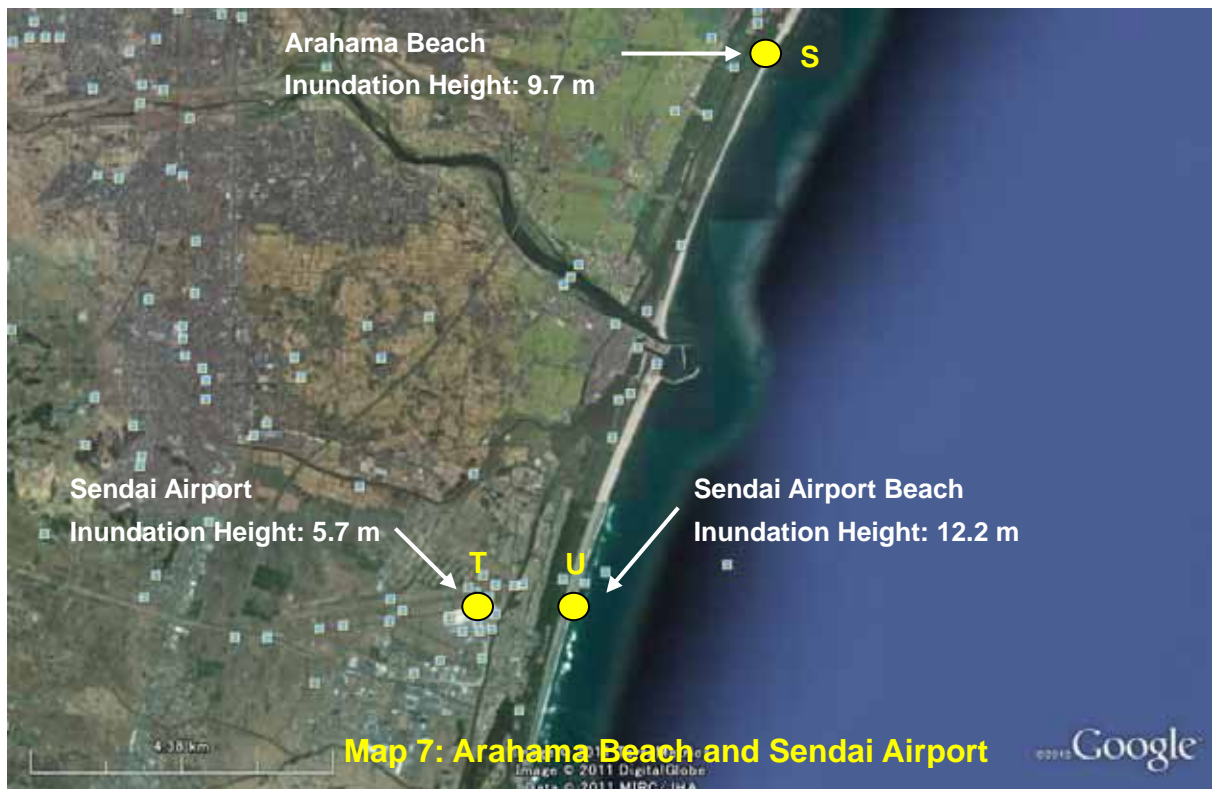
Inundation height of 9.7 m was observed at the point **S** on the Arahama beach and no significant scours were observed behind the coastal dike. However, at the point **U** on the front beach of Sendai airport, where the inundation height was 12.2 m, significant scours were observed behind the coastal dike resulting in its collapse. Inundation height of 5.7 m was observed at the point **T** in the Sendai airport building.
